Test Report No.: ETR2023092501HLW Date: Sep 25, 2023 Page: 1 of 2

NON-Kinking floating line (8-strand rope)

Test Item: Tensile Strength

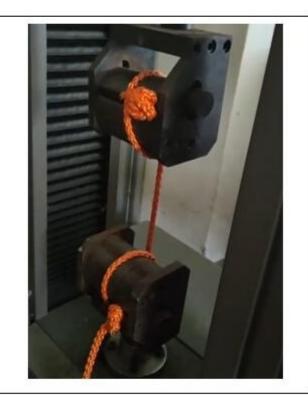
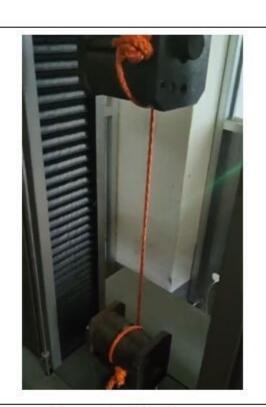
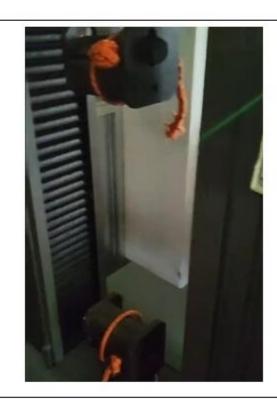
Sample Photos

Dia.8mm x 200mtr, 8mm x 50mtr, 8 x 100mtr Dia. 10mm x 150mtr, 10mm x 50mtr, 10 x 100mtr

Polypropylene.

Specimen Number	Breaking Force (kN)	Specimen Number	Breaking Force (kN)
1. (Dia. 8mm)	6.06	5. (Dia. 10mm)	8.38
2. (Dia. 8mm)	6.12	6. (Dia. 10mm)	8.34
3. (Dia. 8mm)	6.06	7. (Dia. 10mm)	8.25
4. (Dia. 8mm)	6.09	8. (Dia. 10mm)	8.33
